SENIOR LIVING URBAN (EPSOM) LTD GUILD LIVING CARE COMMUNITY EPSOM HOSPITAL WOODCOTE GREEN ROAD

STAGE 1 ROAD SAFETY AUDIT RESPONSE REPORT

MAY 2020

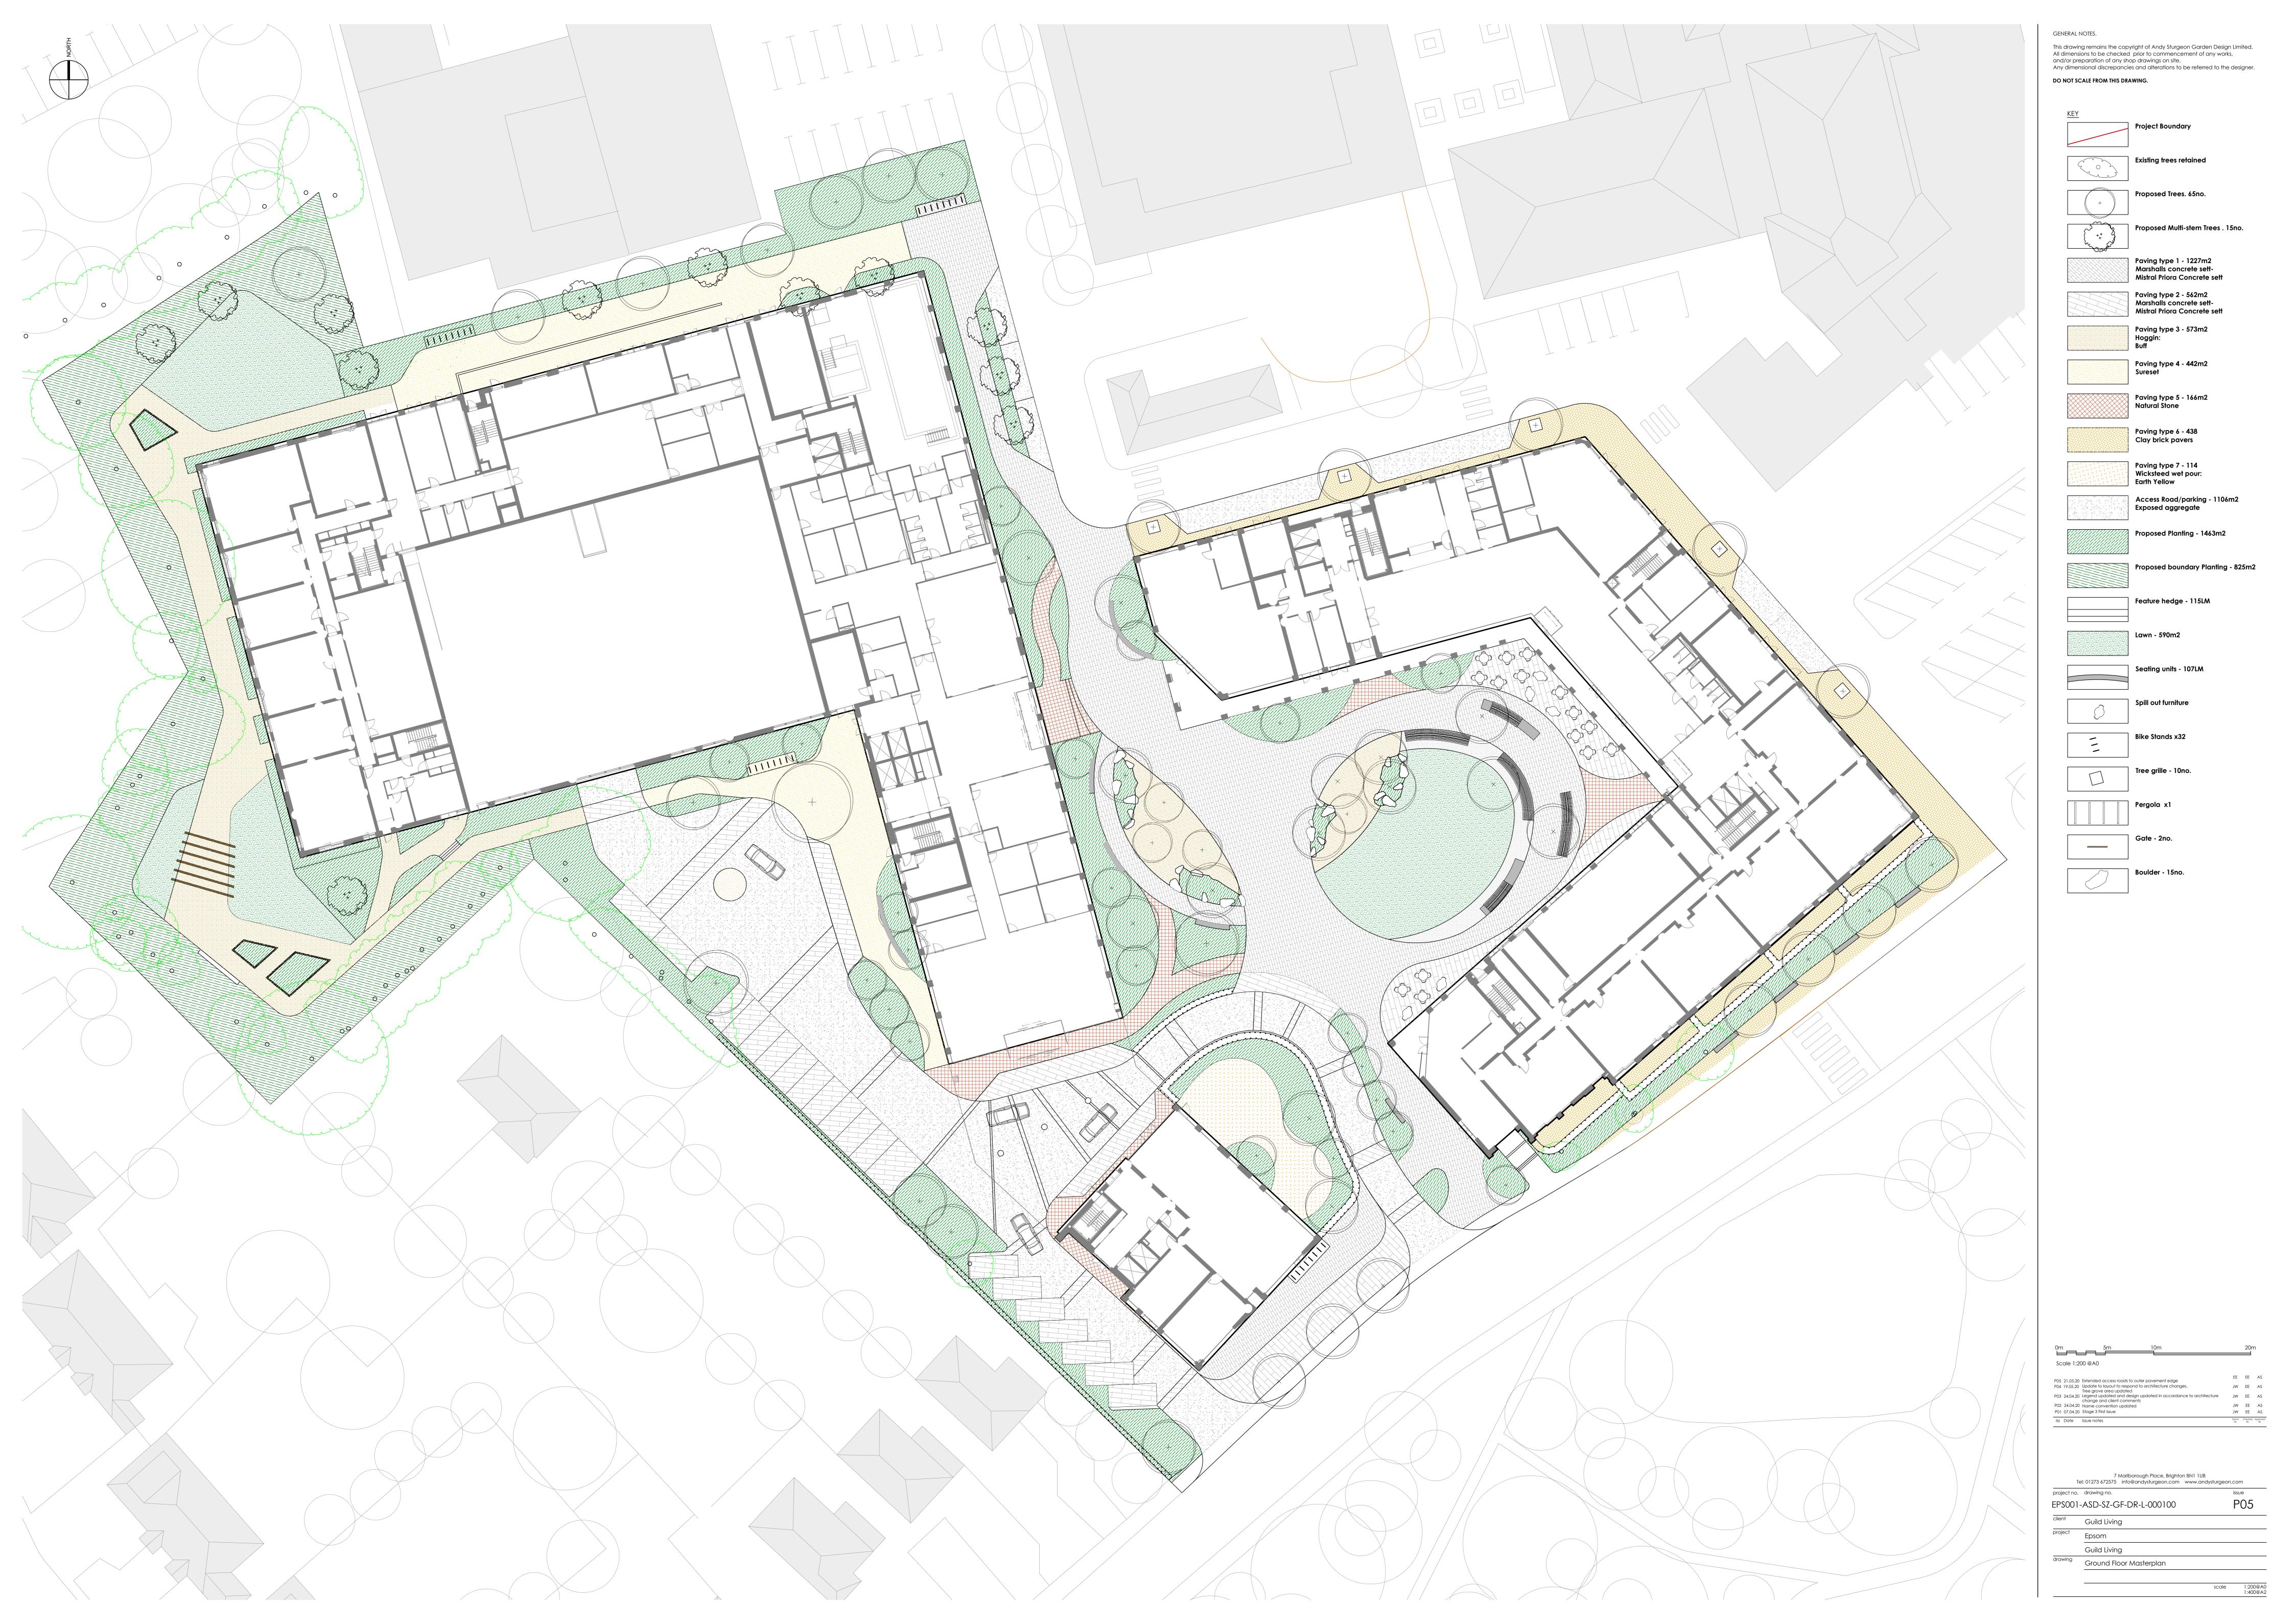
APPENDIX B: Revised Layout Drawing

The recirculation lane provided within the development site abuts the rear edge of footway between the vehicular ingress and egress. The Audit Team are concerned, that without some for of physical measures being provided, vehicles turning right into the recirculation lane could over run the footway, and potential strike pedestrians using the footway. Conversely, without some form of physical measure being provided, pedestrians using the footway may inadvertently stray off the footway and onto the recirculation lane, and subsequently being at risk of being struck by a moving vehicle.

The full height kerbed radii provided at both the site ingress and egress tie into the rear edge of the existing footway on Woodcote Green Road. This could result in vehicles following the kerb alignment and entering the footway, potentially leading to pedestrian/vehicle collisions.

The Audit Team are advised that pedestrians using the footway on the northern side of Woodcote Green Road should be given priority over other road users accessing the development. It is also understood that for this reason tactile paving is not to be provided at either access to aid vision impaired users.

However, the proposed access arrangements include the provision of full height kerbed radii at both access points. This conventional bell-mouth type arrangement may indicate that vehicles accessing the site have priority over crossing pedestrians, this could result in confusion, driver hesitation and/or pedestrian being struck by a moving vehicle. Additionally, lack of provision of tactile paving at dropped crossing points on either side of the vehicle

ingress and egress points could result in visually impaired pedestrians inadvertently walking into the site access vehicular routes.

A number of trees are shown along the site frontage, one of which appears to be within the junction visibility splays, or if not within the visibility splays then very close to them. Even if the trees are intended to be of relatively small girth and have clear stems, they will inevitably have some impact on sightlines; this effect will be greater the closer they are to the egress and will increase with time as the trees grow. This will increase the risks of vehicles emerging from the egress and being struck by passing traffic.

It will be important to provide appropriate signing and road markings to ensure that road users are able to differentiate between the vehicular ingress and egress, in order to reduce the risk of sudden braking and/or late turning manoeuvres.

It is recommended that some form of pedestrian restraint barrier and full height kerb is provided at the rear edge of footway/site boundary. It will be important to ensure that any pedestrian restraint barrier does not obstruction junction visibility splays.

Agreed. A form of physical barrier between the vehicular route and footway will be provided in this location, most likely through the provision of additional landscaping/planters between the trees currently shown. This barrier will be illustrated on future layout plans.

It is recommended that if a bell mouth junction arrangement is to be provided, then the kerbed radii should tie into the channel line of Woodcote Green Road.

Agreed. This has been amended and is illustrated on the updated proposed site layout plan attached to this report at **Appendix B**.

It is recommended that both the ingress and egress are formed of a crossover arrangement including dropped kerbs.

Agreed. This is arrangement is indicated on the updated proposed site layout plan attached to this report at **Appendix B**.

- i. Provide visibility splays in accordance with relevant design standards and ensure that the splays will be kept free from obstruction.
- ii. Any vegetation within the splays should be maintained to ensure that it does not extend beyond a vertical height of 0.6m.
- iii. Do not plant trees within the visibility splays.

Agreed. The proposed site layout will be reviewed, and any obstructions removed from the visibility splay in accordance with the above recommendations.

It is recommended that appropriate 'No Entry' signing and 'No Entry' markings should be provided at the site egress to ensure vehicles are prohibited from turning into the site egress.

It is also recommended that appropriate 'Entry' signing, and 'Entry' or 'One Way' markings should be provided within the site ingress to ensure vehicles enter the site using the appropriate access point.

Agreed. Appropriate markings will be provided at the site ingress and egress in accordance with the above recommendation.
