Epsom Hospital

Ground Investigation Report

Guild Living

Doc ref: 12053-HYD-XX-XX-RP-GE-1000-P4

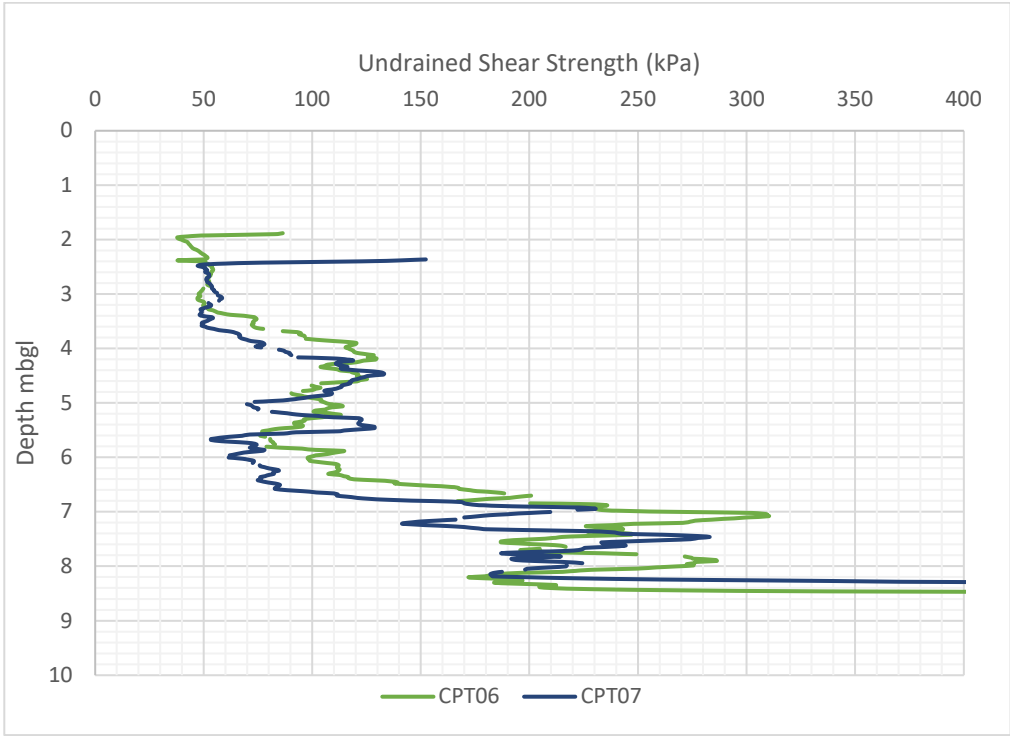
Table 6-9: Undrained Shear Strength with depth for CPT Probes CPT 06 - 07. Correlation based on Mayne & Peuchen 2018 (OC Fissured).

Range of insitu Shear strength profiles through the London Clay and the Woolwich Formation beneath the central area of the site (all terminating on the dense sands of the Upnor Formation) as determined by CPT 06 and 07.

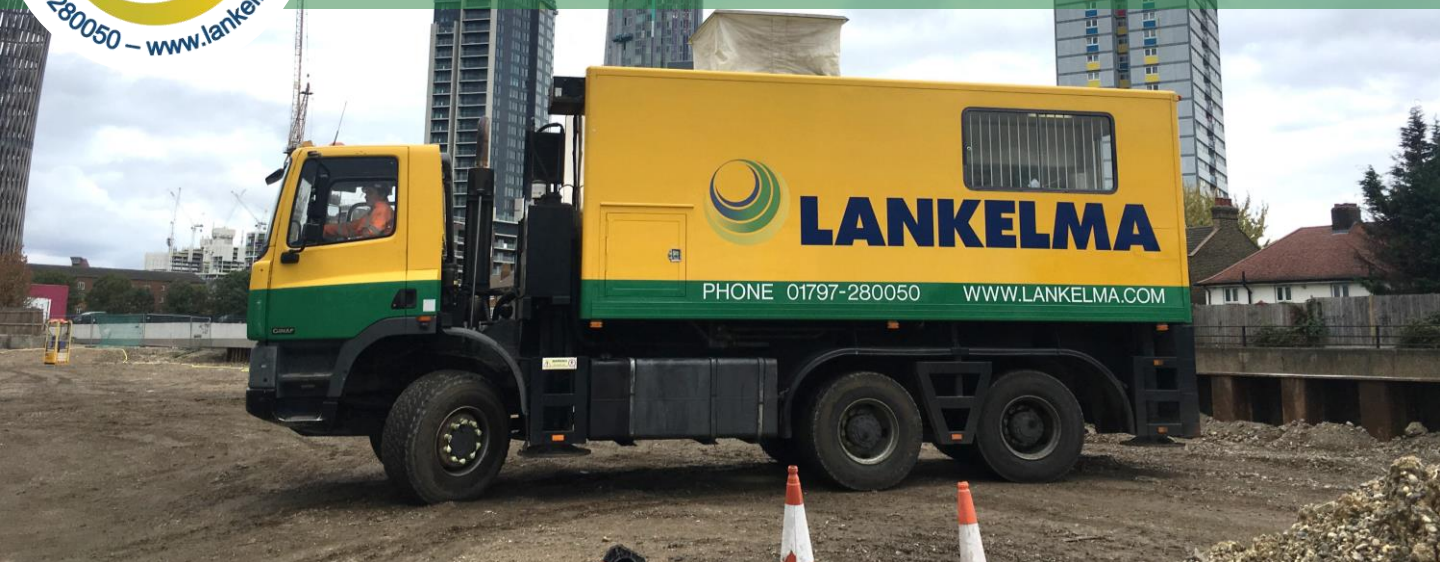
Wheeled truck

Rig weight	31 T
Max. operating ram capacity	27 T
Max. travelling speed	86 km/h
Drive system	6x6 wheel drive (rear axle steer)
Jack plate dimensions	260 mm Φ
Jack arrangements	4nr. jacks total
Maximum ground clearance on jacks	390 mm
Maximum ground bearing pressure	Tracking-pushing – 239 kPa Pulling – 479 kPa
Maximum gradient	15 degrees
Maximum traversing gradient	20 degrees (operator assessed)
Noise output at 2 m	Testing – 79 dBA Driving – 84 dBA
Clamp arrangement	36-60 mm hydraulic clamp
Ram stroke	1.24 m
Typical production	100 m+ of standard CPTu testing per day (depending on conditions and access)
