ROWAN HOUSE, EPSOM
GENERAL HOSPITAL, DORKING
ROAD, EPSOM, KT18 7EG

Client Ref: Epsom_Hospital_
Report Ref: GS-6266220
Grid Ref: 520385, 159755

The Phase 2 Geo-environmental and Geotechnical Assessment Report herein has been formulated to inform design considerations and to assist with supporting the discharge of future environmental planning conditions associated with the various redevelopment plans. This report provides an assessment of the ground conditions and contaminated land constraints, and provides a quantitative understanding of the land quality in order to better inform the requirement for potential remediation and/or mitigation associated with redevelopment of the site.

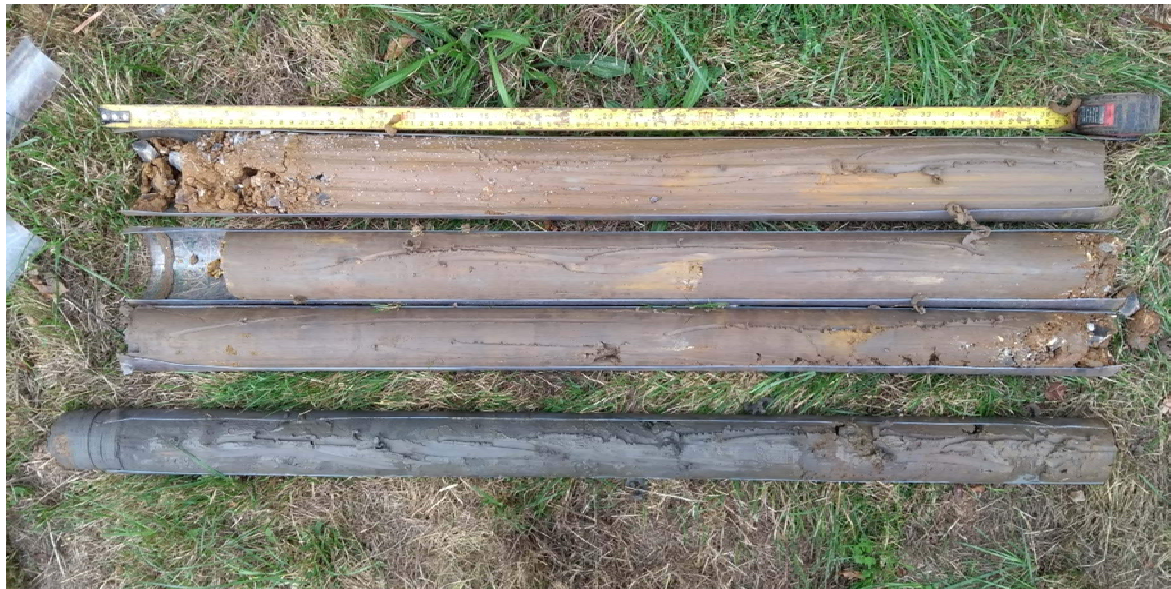
ARCADIS Window Sample Photography Sheet **WS106**

WS106 – 1.20 m – 5.00 m bgl

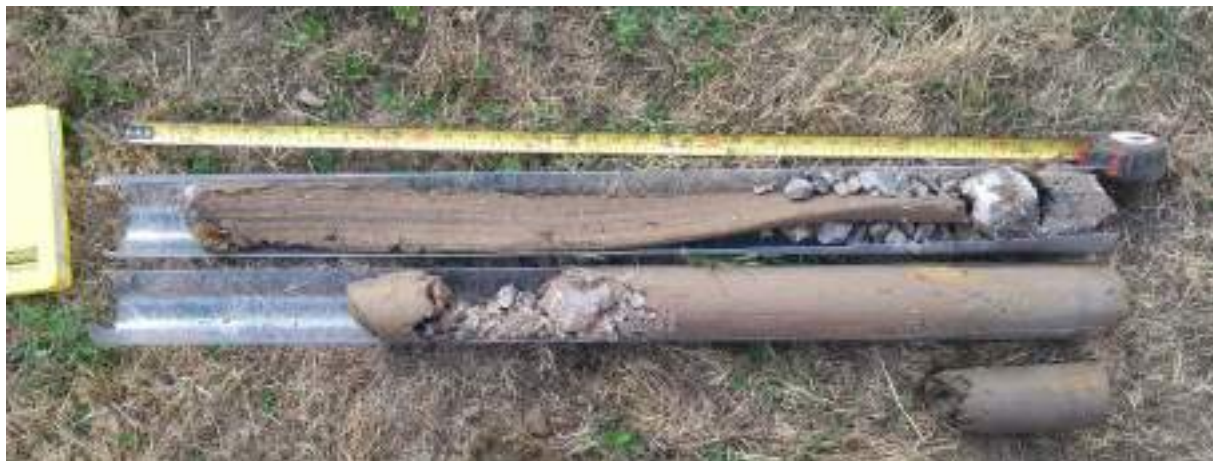
ARCADIS Window Sample Photography Sheet **WS107**

WS107 – 1.20 m – 4.00 m bgl

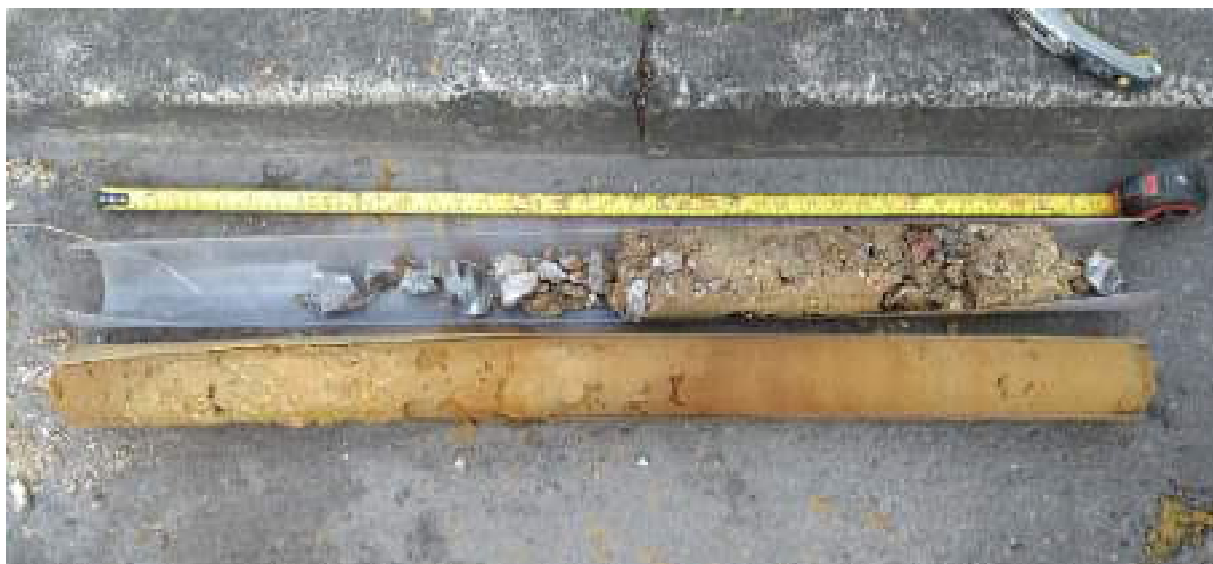
ARCADIS Window Sample Photography Sheet **WS109**

WS109 – 1.20 m – 3.00 m bgl

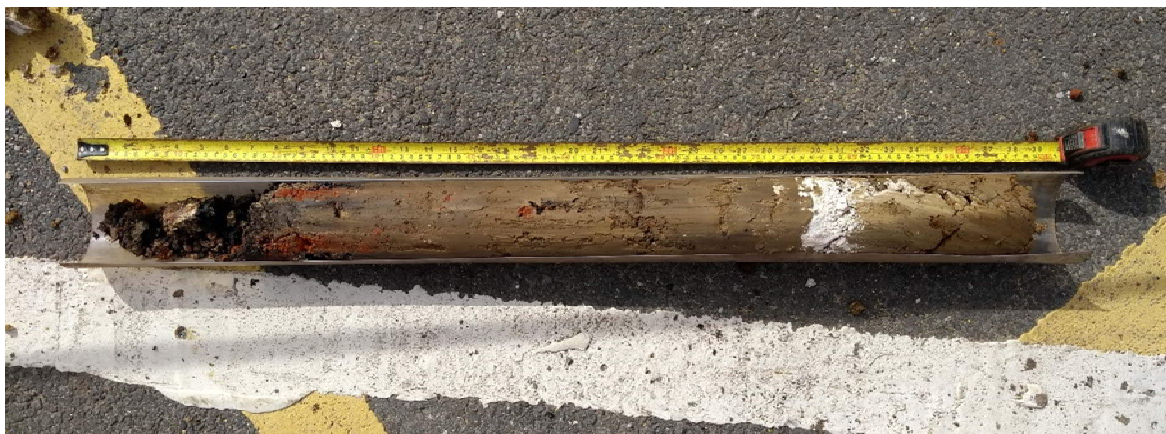
ARCADIS Window Sample Photography Sheet **WS112**

WS112 – 1.20 m – 2.00 m bgl
